**SOME CREEP CHARACTERISTICS OF
BERYLLIUM-COPPER AT 300°C**

James G. Curry

MASTER OF SCIENCE
IN
MECHANICAL ENGINEERING

from the
United States Naval Postgraduate School

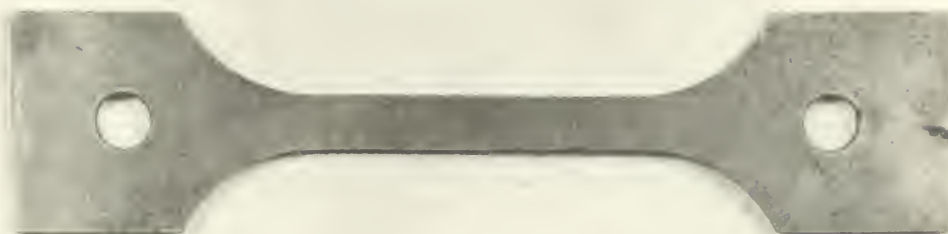
Figure 8 - Test Specimens

At the beginning of this investigation it was assumed that the customary creep specimen design (see Figure 8c), being employed in the Creep Testing Laboratory of the U. S. Naval Postgraduate School, would be adequate. Upon completion of the first test on a specimen, in the HT-316 condition, based on this design it appeared that this assumption was justified as the fracture occurred within the gage section. However, the next four fractures occurred at the grip section as shown in Figure 9c). These tests were conducted on specimens in the H and HT-316 conditions.

This, obviously, meant that a design change was in order. A 60% increase in the width of the grip section was considered sufficient; this modification constituted the intermediate design as shown in Figure 8b. Four tests were then conducted using specimens of such design, in the A, H and HT-316 conditions. All of these tests resulted in fractures in the same location (see Figure 9b) as in the previous four tests.

- (a) Final Design
- (b) Intermediate Design
- (c) Initial Design

step in this development would be to conduct the short-time tensile tests at 300°C. However, due to time considerations, it was felt that another modification would resolve the situation. Accordingly, the width of the gage section was reduced by 37.5% resulting in the final design as shown in Figure 8a. Pertinent dimensions of all three test specimens are shown in Table III.
